# The First Annual Navy Corrosion Control Workshop

# Microbiologically Influenced Corrosion in Copper and Nickel Seawater Piping Systems

## Executive Summary

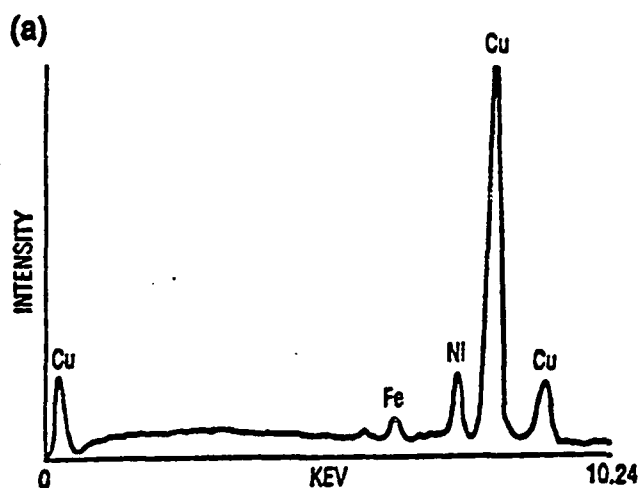
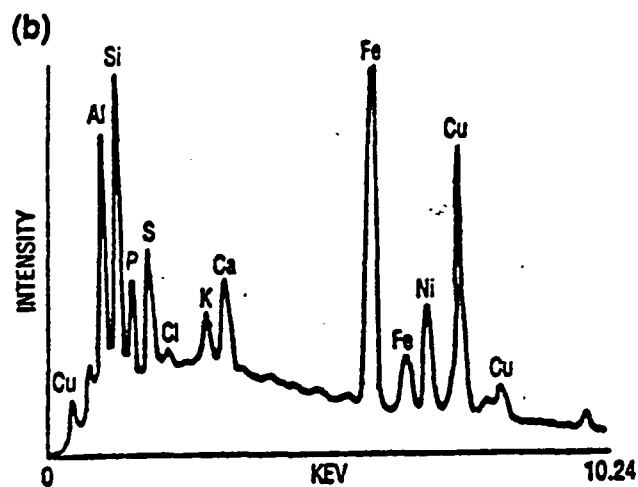
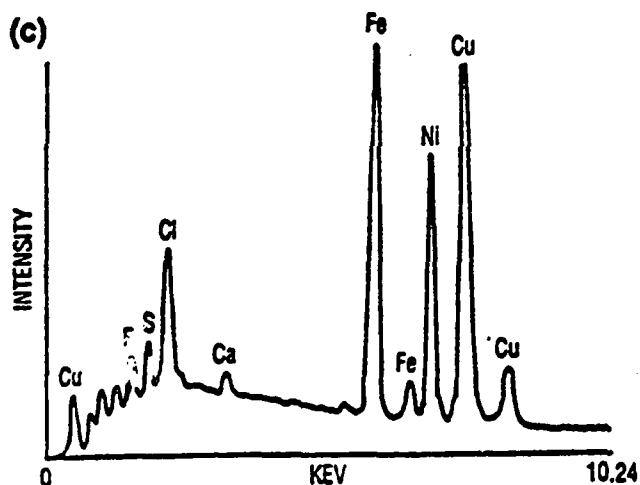
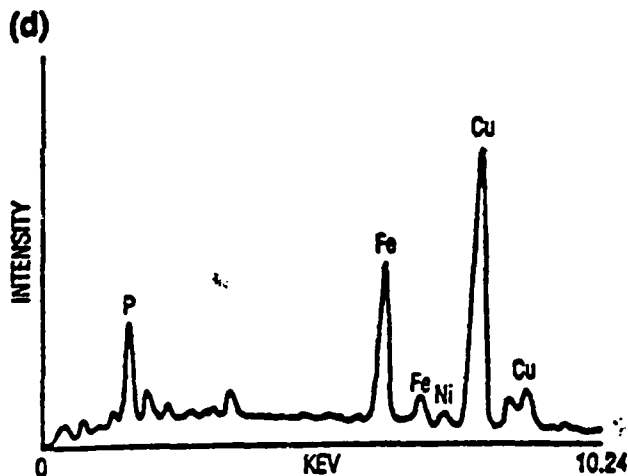
**A. EDAX SPECTRUM OF CLEAN COPPER ALLOY BEFORE EXPOSURE**

**B. EDAX SPECTRUM OF PITTED REGION OF COPPER ALLOY, SHOWING ACCUMULATION OF ALUMINUM, SILICON, PHOSPHORUS, SULFUR, CALCIUM AND ELEVATED AMOUNTS OF IRON AND NICKEL.**

**C. EDAX SPECTRUM OF PITTED REGION OF COPPER ALLOY, SHOWING THE ACCUMULATION OF CHLORINE AND ELEVATED AMOUNTS OF IRON AND NICKEL.**

**D. EDAX SPECTRUM OF SPONGY MATERIAL BENEATH BACTERIA, SHOWING AN ACCUMULATION OF PHOSPHORUS, AN ENRICHMENT OF IRON AND A DEPLETION OF NICKEL IN THE BASE OF THE PIT.**

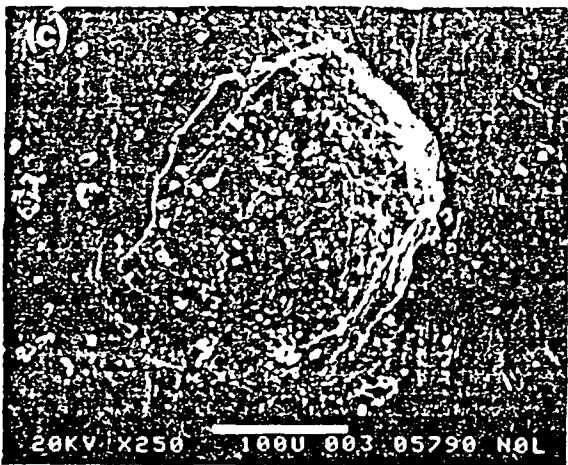
A AND C. BLISTERS ON THE SURFACE OF NICKEL TUBE.

B AND D. PITS ON NICKEL TUBE.

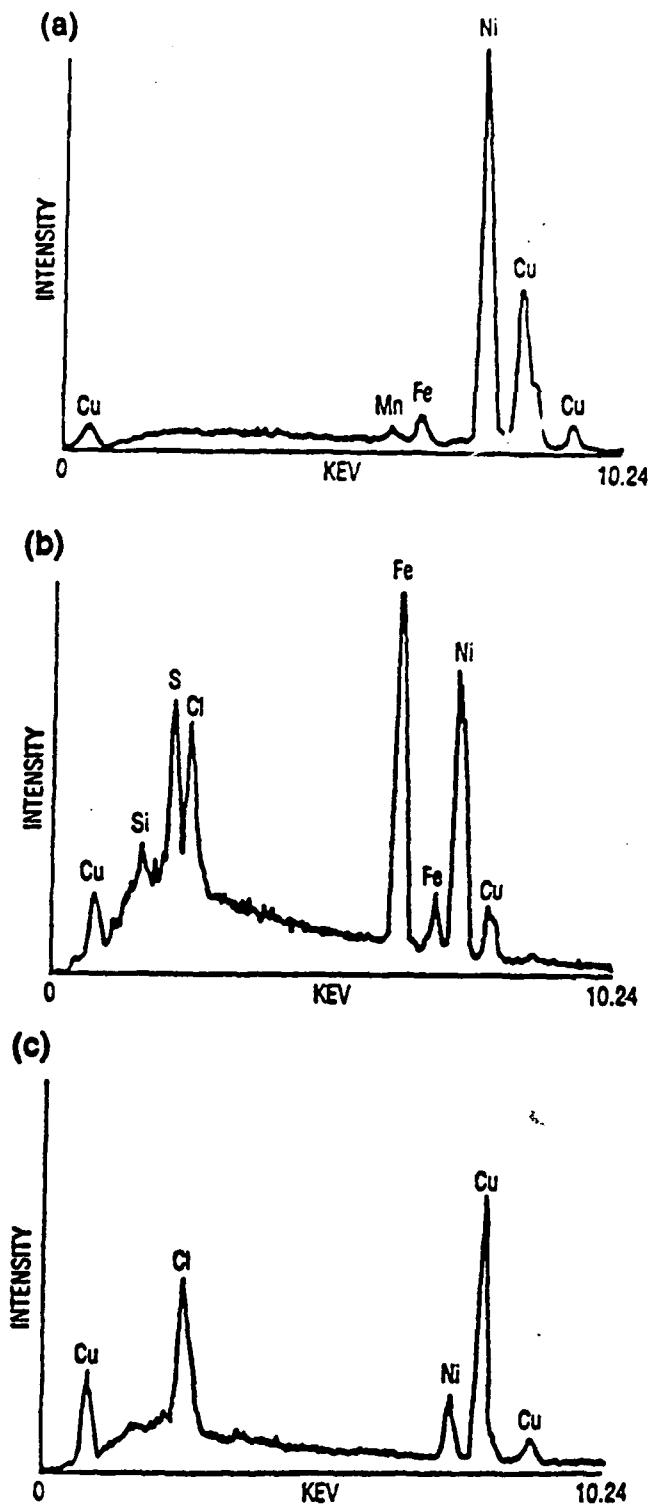
**A. EDAX SPECTRUM OF UNEXPOSED NICKEL ALLOY.**

**B. EDAX SPECTRUM OF NICKEL ALLOY AFTER EXPOSURE TO ESTUARINE WATER FOR 6 MONTHS SHOWING ACCUMULATIONS OF SILICON, SULFUR, AND CHLORINE WITH ELEVATED CONCENTRATIONS OF IRON AND NICKEL.**

**C. EDAX SPECTRUM OF THE RESIDUAL METAL IN THE BASE OF THE PIT SHOWING NICKEL DEPLETION AND COPPER ENRICHMENT.**

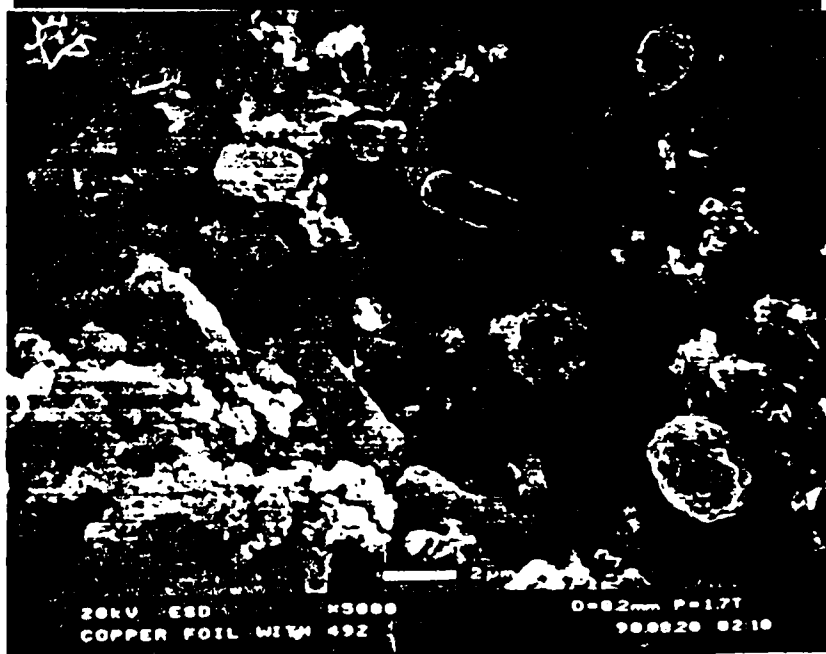
**BACTERIA ASSOCIATED WITH CORROSION PRODUCTS.**

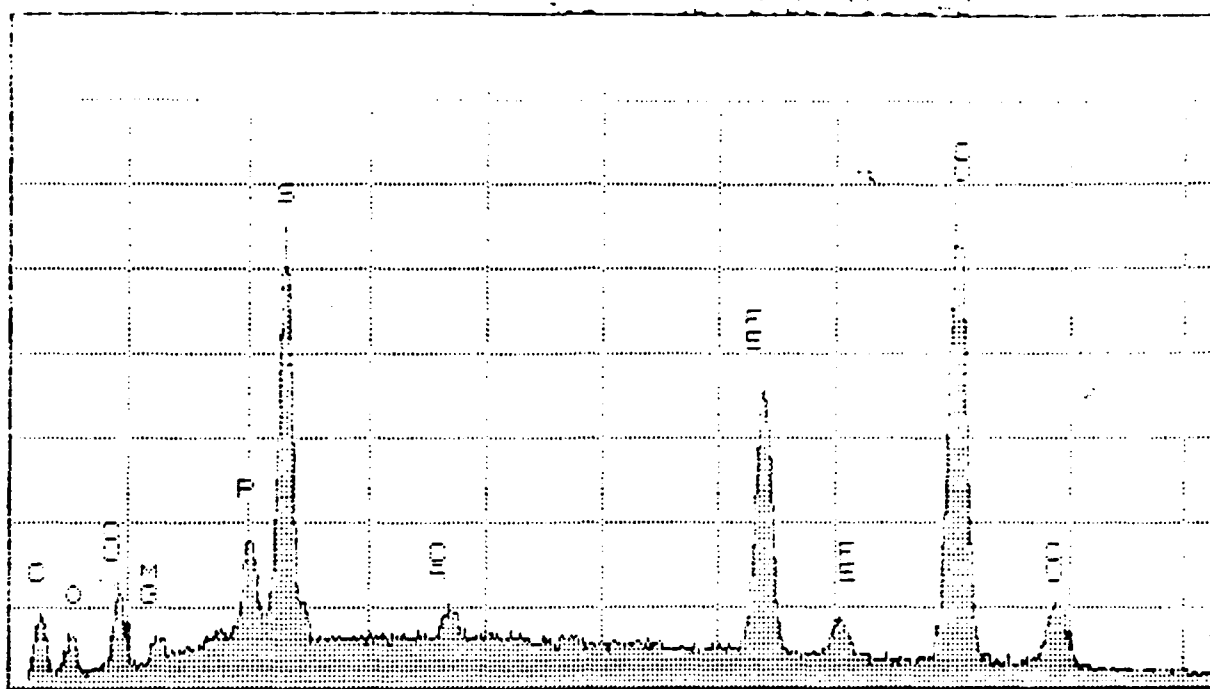
EDAX SPECTRUM OF 99CU COLONIZED BY CULTURE IV.

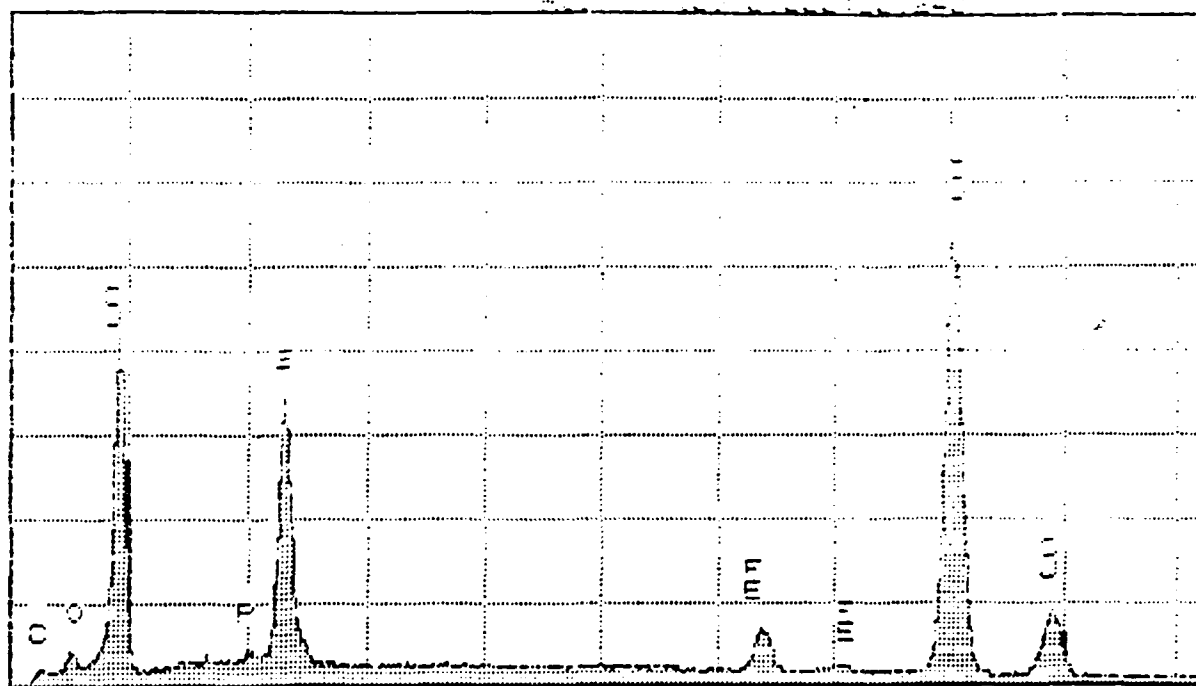
**EDAX SPECTRUM OF THE 99CU METAL SURFACE UNDER CULTURE IV.**
